EXECUTIVE SUMMARY

Phase I Environmental Site Assessment 10720 - 10750 East Colfax Avenue Aurora, Colorado ATEC Project No. 41-07-94-00109

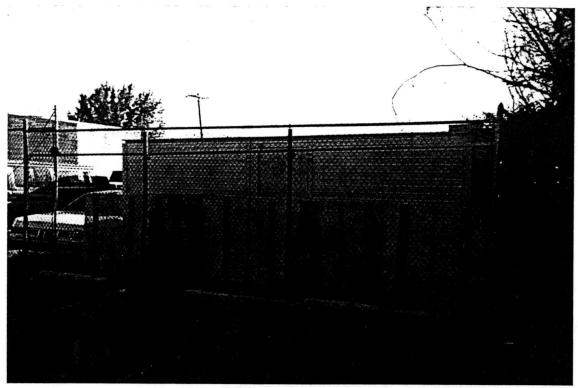
VIEW OF STORAGE TRAILER AND AUTOMOBILES ON SOUTHERN PORTION OF THE SITE

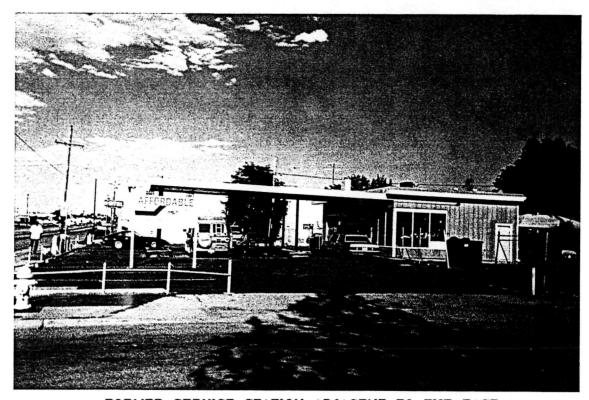
Our review of the city directories indicated the adjacent property to the east at 10800 East Colfax Avenue was a service station, Jamaica Chevron from at least 1962 until a date between 1979 and 1981. In 1981 that site was listed as Hansen Automotive. Adjacent parcels to the south, such as 1458-60 Ironton Street and 1445-49 Jamaica Street were listed, beginning in the early 1960's, as various businesses typically associated with automobile repairs.

FORMER SERVICE STATION ADJACENT TO THE EAST

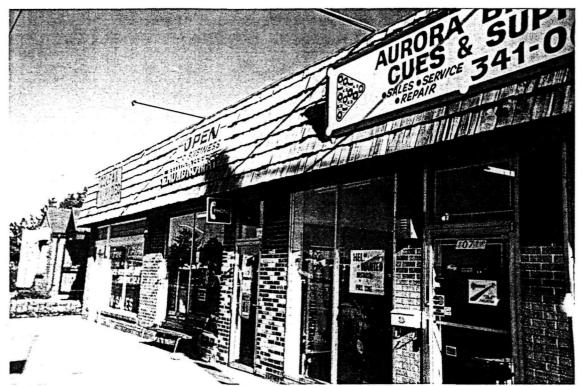
VIEW OF 10720 AND ADJACENT BUSINESSES

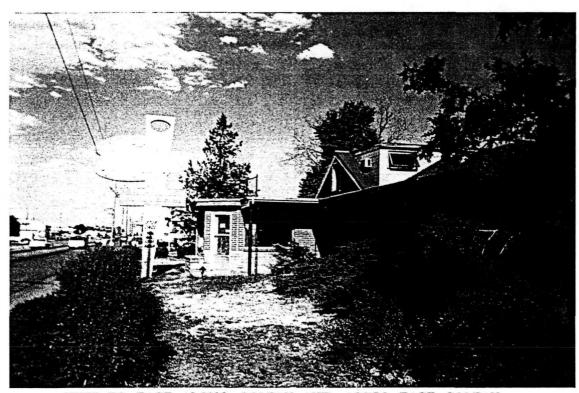
VIEW TO EAST ALONG COLFAX AVE. 10750 EAST COLFAX

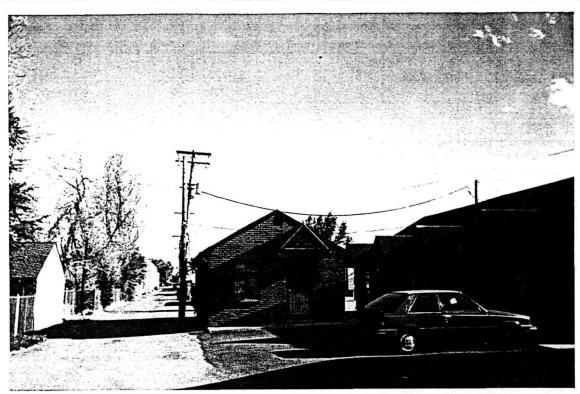
VIEW TO SOUTH THROUGH CENTRAL PORTION OF SITE

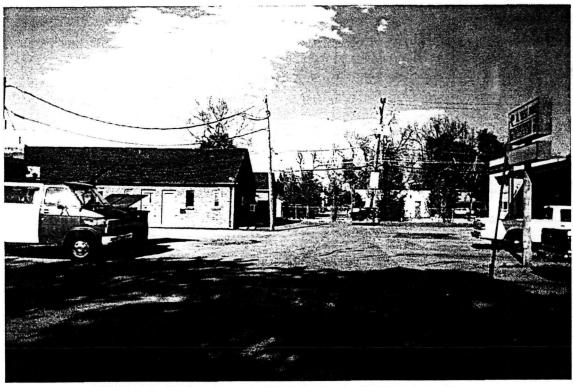
VIEW TO EAST FROM WESTERN PORTION OF SITE
